Mold Remediation Protocol Report

11701 Silvermoon Dr.
OKC, OK 73162

MEMORANDUM 001

Re.: Burned House Inspection
11700 Silvermoon Drive
Oklahoma City, Oklahoma

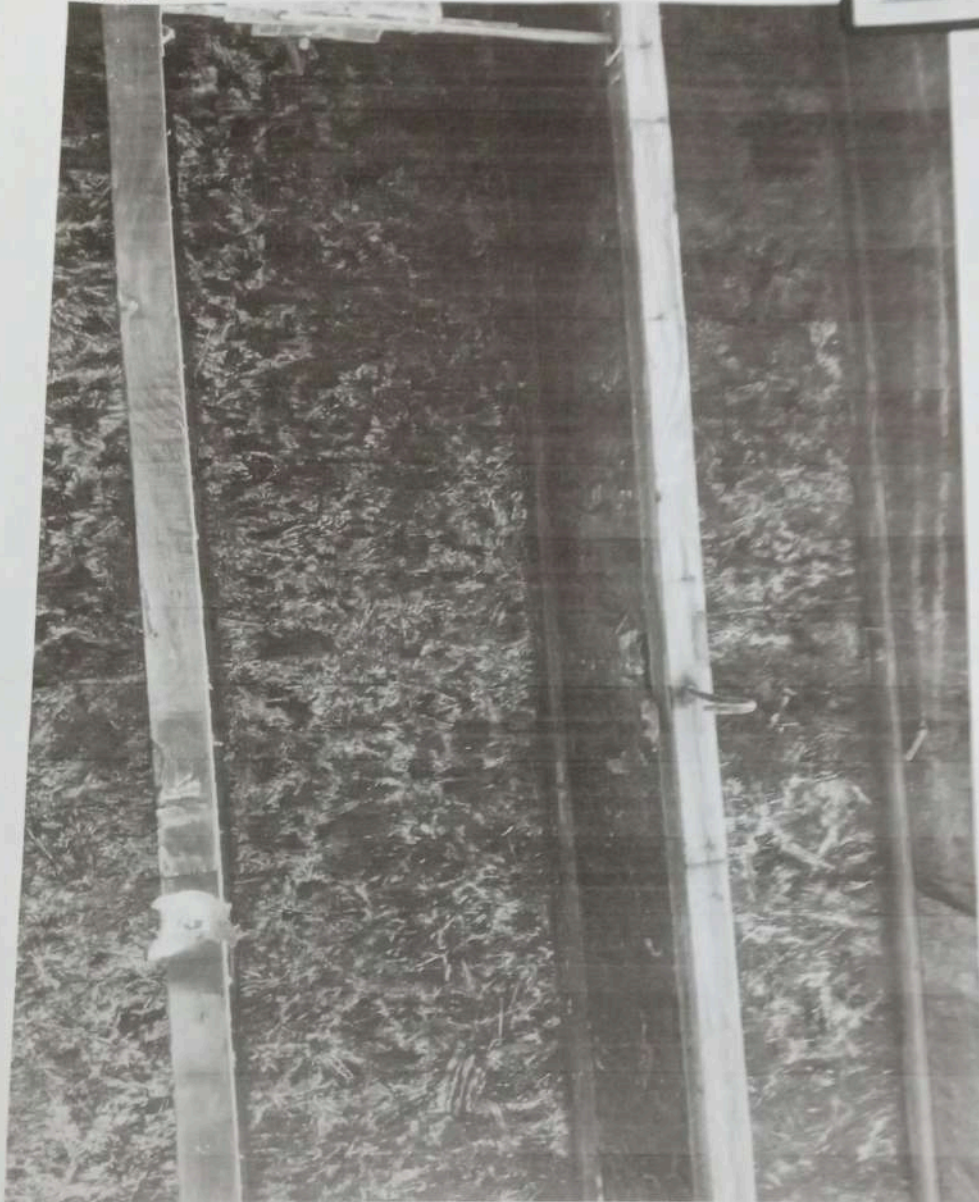
Picture 6

Upon inspection, visible microbial growth was found on the upstairs flooring and 70% of the framing and plates. Please refer to specific protocol below.

Inspect and remediate all walls, floors, cabinets, ceilings, etc, showing evidence of water intrusion. This would include those areas with known leaks, water stains, water damage, or resultant mold growth. If additional evidence of water intrusion is found, continue removal 3 feet (ft) beyond the end of the evidence, in accordance with S520 Standard for the expanded areas. The following areas require remediation (removal) at this time. Further, the remediation personnel doing the application must be wearing the proper personal protective equipment. Furthermore, when the ozone is applied, the levels in the air must be below OSHA's Permissible Exposure Limits (PEL) of 0.1 parts per million (ppm) on an 8 hour Time Weighted Average (TWA) basis. Finally, the room must be thoroughly ventilated before it is occupied again.
